# HISTORIC PROPERTY INVENTORY FORM

Field Site No. 340 OAHF No. \_\_\_\_\_ Date Recorded 24 Jan 1995  
Site Name Historic Waste Neutralization Facility Revised 30 June 1997  
Common \_\_\_\_\_  
Field Recorder B.S. White, I.C. Lindsay  
Owner's Name U.S. Department of Energy, Richland Operations Office  
Address P.O. Box 550  
City/State/Zip Code Richland, WA 99352

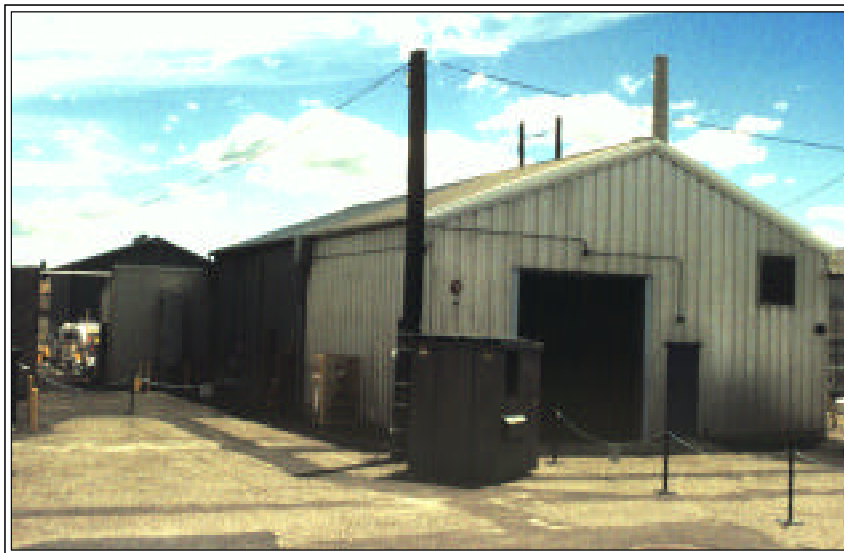
Photo at right: Roll 270, frame 17  
View of west and north facades

The original 340 Building consisted of an open-air subsurface concrete vault and Transite control room with a total area of 40 feet by 42.5 feet. The vault alone measures 37.8 feet by 25.6 feet by 25 feet deep and contains two 15,000 gallon stainless steel tanks. A concrete cover was added to the vault in the late 1950s due to concerns over background radiation from the exposed tanks. In 1980 new charcoal filters, HEPA filters, exhaust fans, and improved instrumentation and pumps were added at the east end of the vault to filter air from inside and around the tanks. The control room has a shed roof and contains an operating gallery with a computer-automated monitoring system. The double door to the operating gallery is on the north wall. The original sample room at the south end of the building now serves as a mechanical equipment room, though the original sample wells and piping are still present. A compressor room containing air compression equipment is also on the south end of the control room, and access to both of these small rooms is through a door on the south end of the building. The original Transite siding on the control room was covered over with stucco in the late 1980s for improved insulation. Around 1959, a steel panel addition measuring 40 feet by 42 feet by 23 feet high was added to the west end of the 340 facility and offset slightly to the south, doubling the size of the facility. The gabled roof of the addition runs east-west. A single door is located on the north wall providing access to a large decontamination area with bare concrete floors. Around 1962, another steel addition of identical size was built against the west wall of the previous addition. The west elevation of the addition has a bay door for vehicle entry as well a single pedestrian door. On the south wall of the addition, there are a set of double windows with metal frames. The interior of the building consists largely of open storage with a change room/office in the south wall. The floors are unfinished concrete.
